Commercial
Site
Assessment™
Tier II

Association

2020 Season

Commercial Site Assessment™

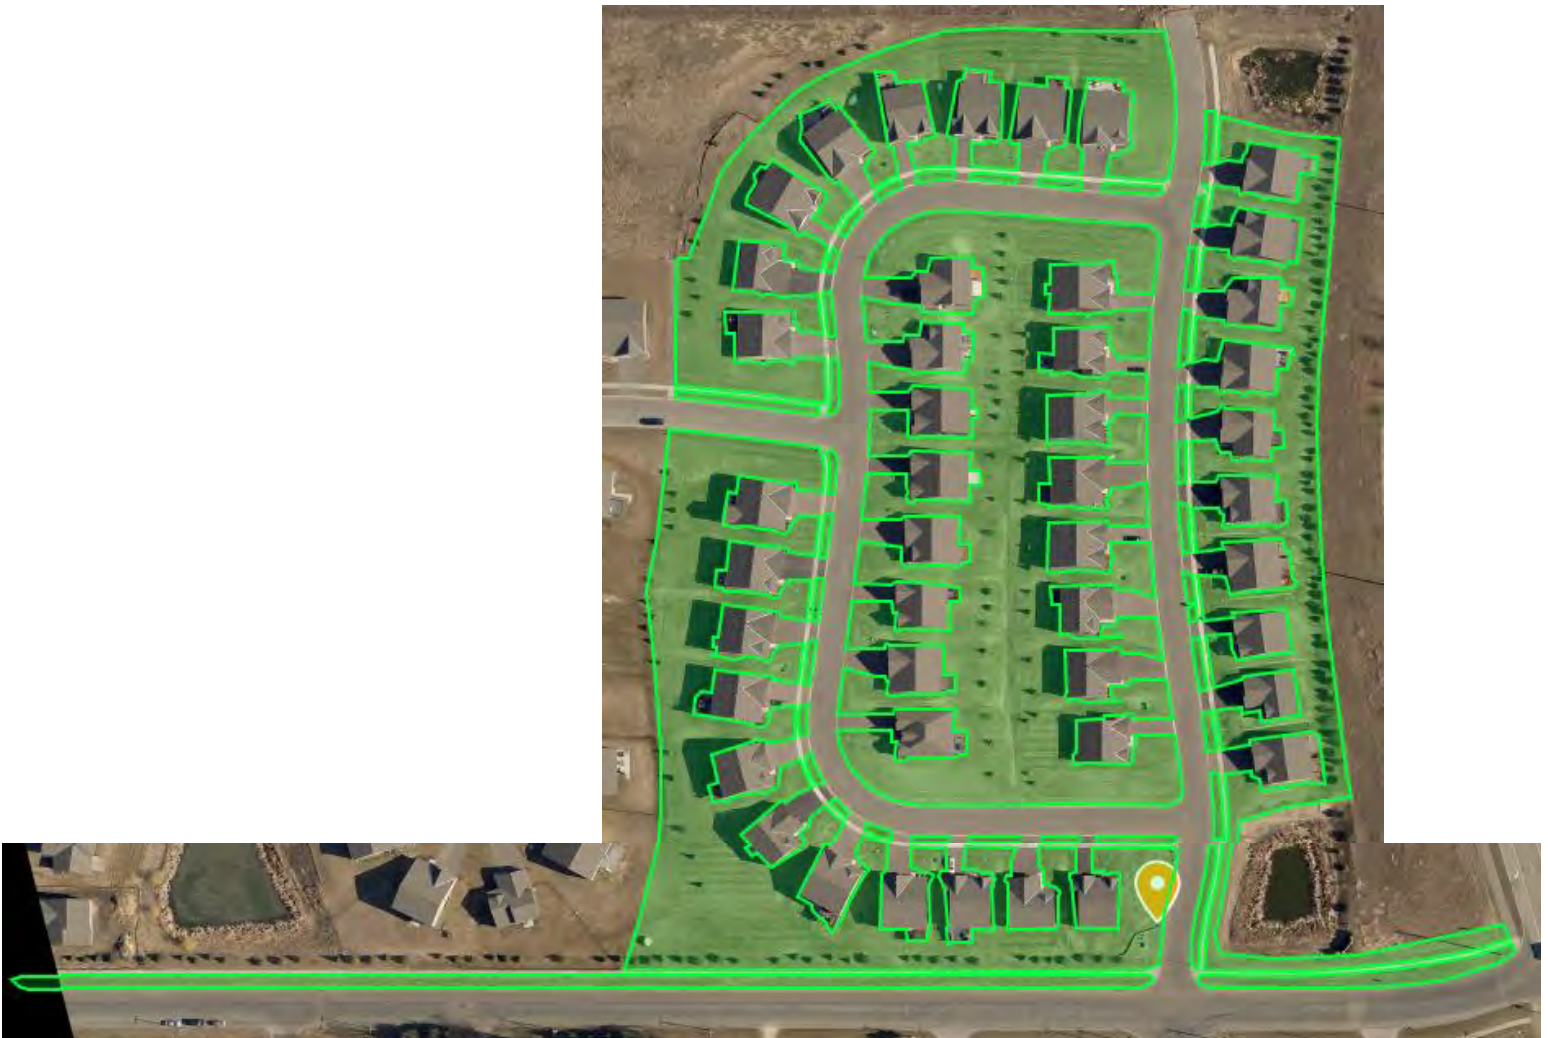
Association A Irrigated Area

Irrigated Acres: 8.24

Irrigated *ft*²: 358,762.27 *ft*²

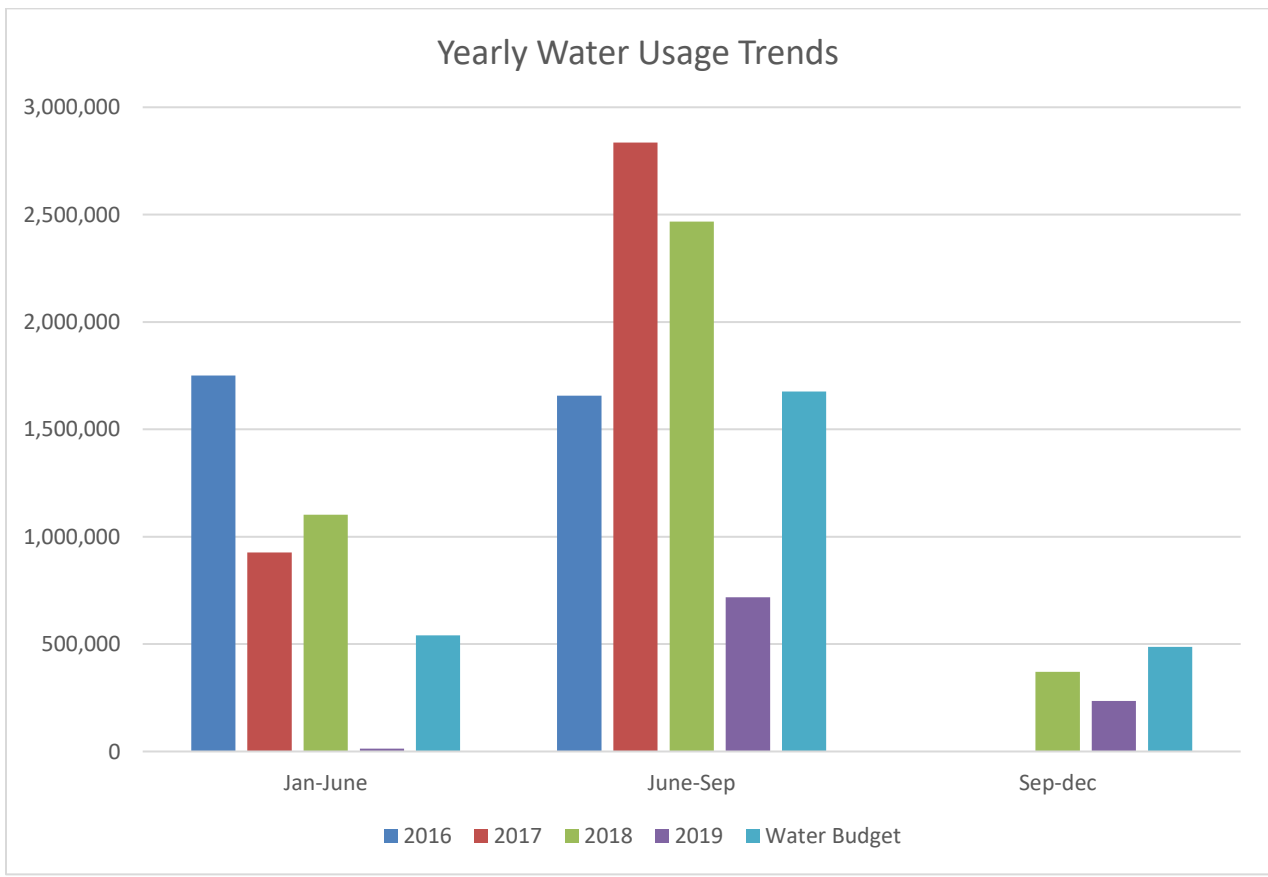
Water Budgeting

Month	2016 Usage	2017 Usage	2018 Usage	2019 Usage	Avg Usage	Water Budget
Jan-June	1,751,000	927,000	1,103,000	0	945,250	540,796
July-Sept	1,657,000	2,836,000	2,467,000	731,000	1,922,750	1,676,468
Sept-Dec	0	0	371,000	235,000	151,500	486,717
Total (gal)	3,408,000	3,763,000	3,941,000	966,00	3,019,500	(75% eff) 2,703,981
