# 2021 Middle Creek Restoration at Highview Ave

## Overview

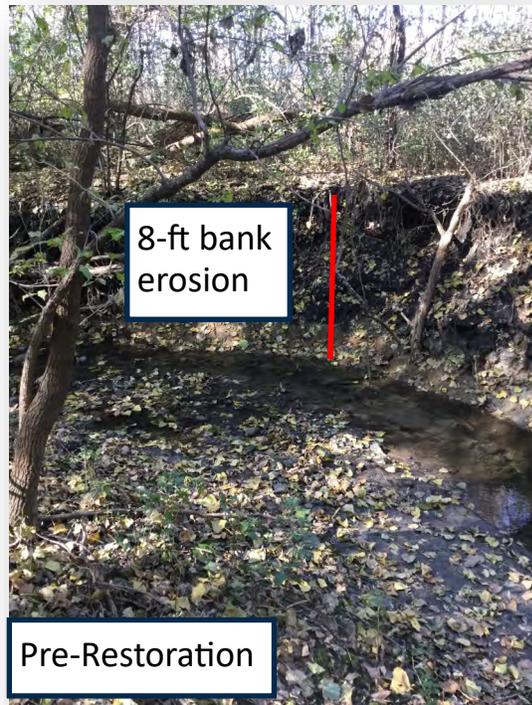
8-ft bank erosion

(Left) Prior to restoration, steep slope grades shaped by years of high velocity flows contributed significant sediment volumes to the stream.

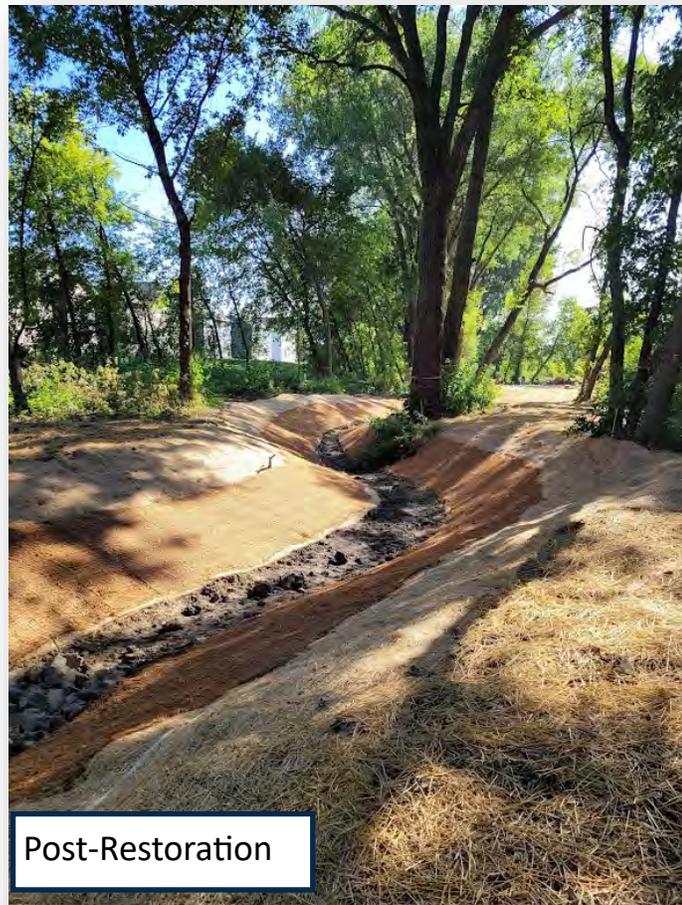
Post-Restoration

(Right) As part of the restoration, slopes were shaped to support more controlled flow regimes, mimicking the contours of a natural stream course.

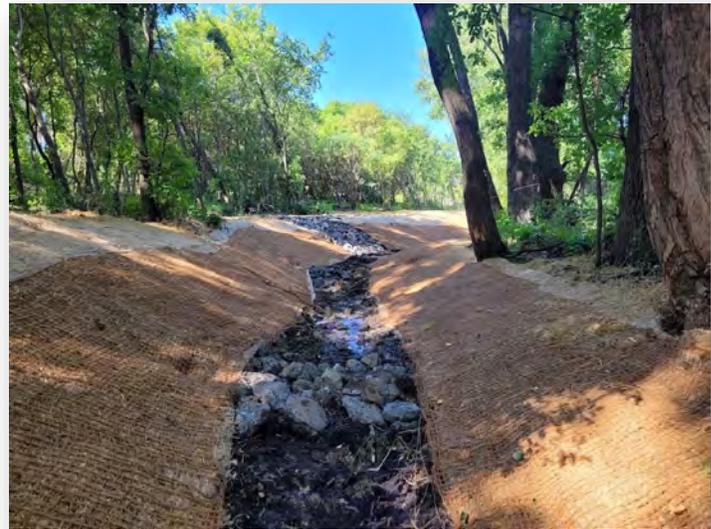
(Above) Placing veins of rip rap (larger diameter rock) along the channel helps disperse stream flow energy, keeping channel sediment in place.

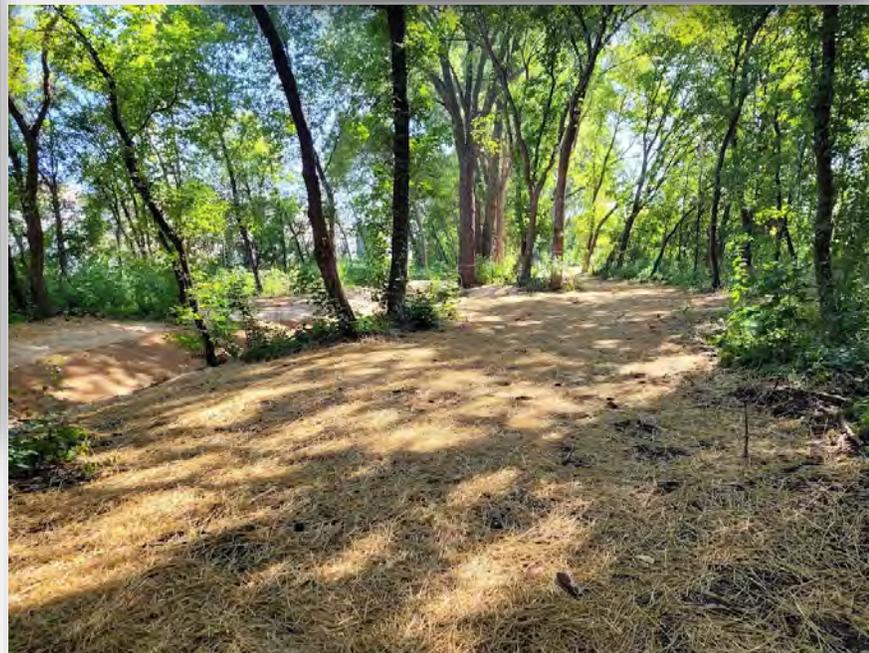
(Right) Thinning tree growth along the channel brings additional light to the woodland understory, allowing native ground species to flourish.

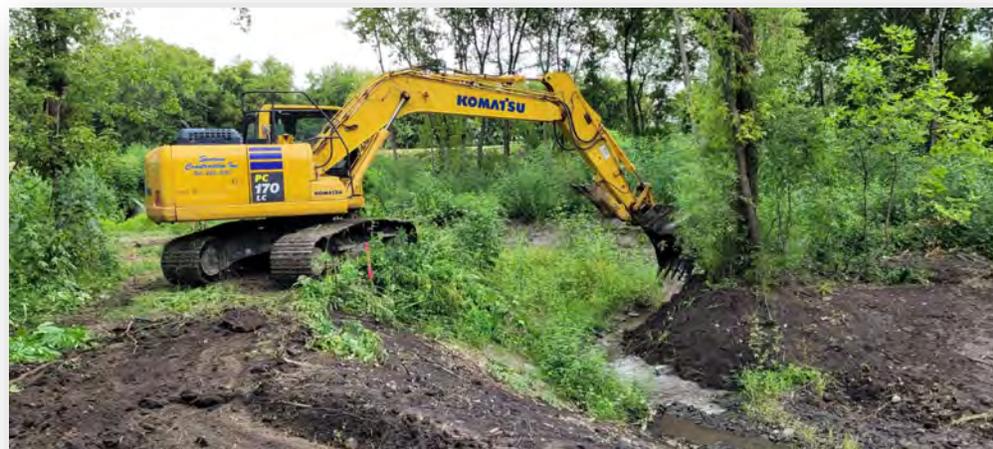
(Left) Reshaping bank slopes takes place prior to spreading of native seed and stabilizing using erosion control blanket along the south channel of the restoration. All up-slope areas that equipment used to access bank slopes were seeded with a native ground cover and stabilized using straw mulch.
